Vassar College

Getty Foundation Campus Heritage Grant

Historic Preservation Design Manual

June 15, 2007

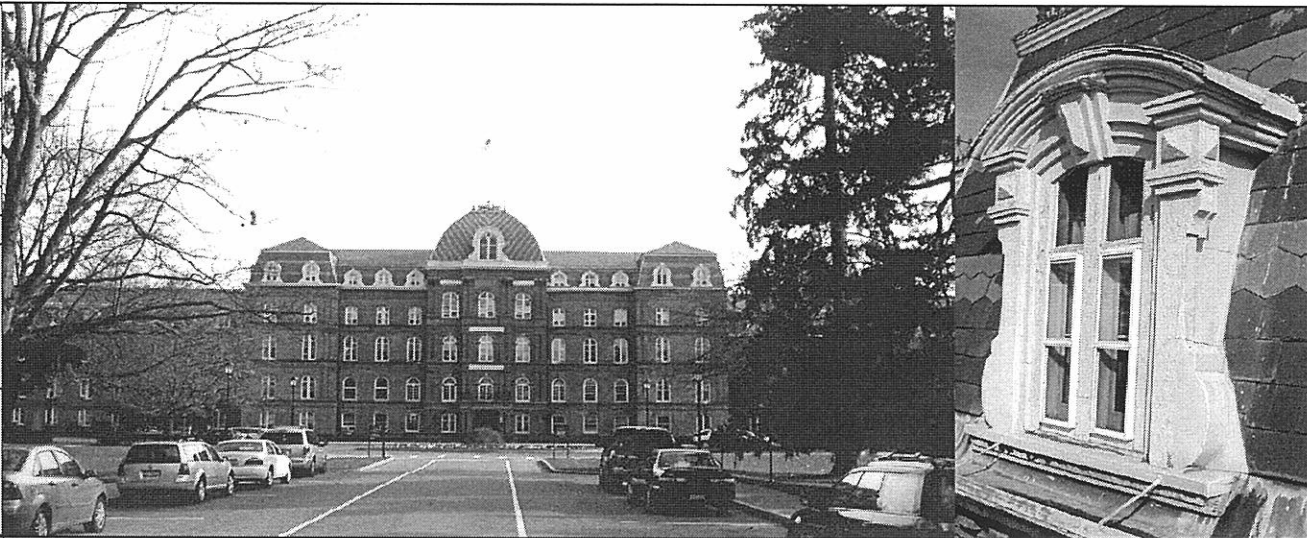
Item	Year of Installation	End of Service Life Year				2007	2008- 2010	2011- 2016	2017+		
1	Roof Construction														
1a	Pitched	Purple and unfading green slate mansard.	Poor	North and South Towers.	1865	1990	Weathertight, aesthetically pleasing.	Limited review, 2004.	Implement restoration program to replace roof systems.	X				125+	South tower has had new slate installed approx. 20 yrs ago, but several deficiencies require intervention.
		Purple and fading green slate mansard	Good	All remaining mansards other than north and south towers.	1990	2115	Weathertight, aesthetically pleasing.	Limited review, 2004.	No recommended action, except for implementation of periodic maintenance program to replace cracked or broken slates.					125+	Unfading green, rather than fading green, was the originally intended slate color.
		Purple slate roof areas	Excellent	Central wing, west elevation, immediately adjacent to central dome.	2006	2131	Weathertight, aesthetically pleasing.	Full replacement, 2006.						125+	New slate: North Country Unfading Purple (Hues of Heather), quarried in Newfoundland, Canada; and Vermont unfading green. Supplier: North Country Slate, Toronto, Canada.

Good-fair	Central wing, including two minor east-west hipped roofs.	1990	2115	Weathertight, aesthetically pleasing.	Limited review, 2004.						125+	
		Purple and unfading green dome (rounded hip)	Good-Fair	Central , west elevation dome.	1990	2115	Weathertight, aesthetically pleasing.	Limited review, 2004.						125+	
		Black asphalt shingles	Excellent	East elevation central roof area.	2006	2056	Weathertight.	Full replacement with copper flashings, 2006.						50	
		Standing seam copper	Poor	Eave flashing of north, central, and south wings, and valleys of north & south towers.	1980	2010	Weathertight, Structurally Sound	Limited review, 2004.	Replace with new copper standing seam system.	X	X			50	Valleys of north and south towers scheduled for 2007; eave flashing of north, central, and south wings for 2008-10.

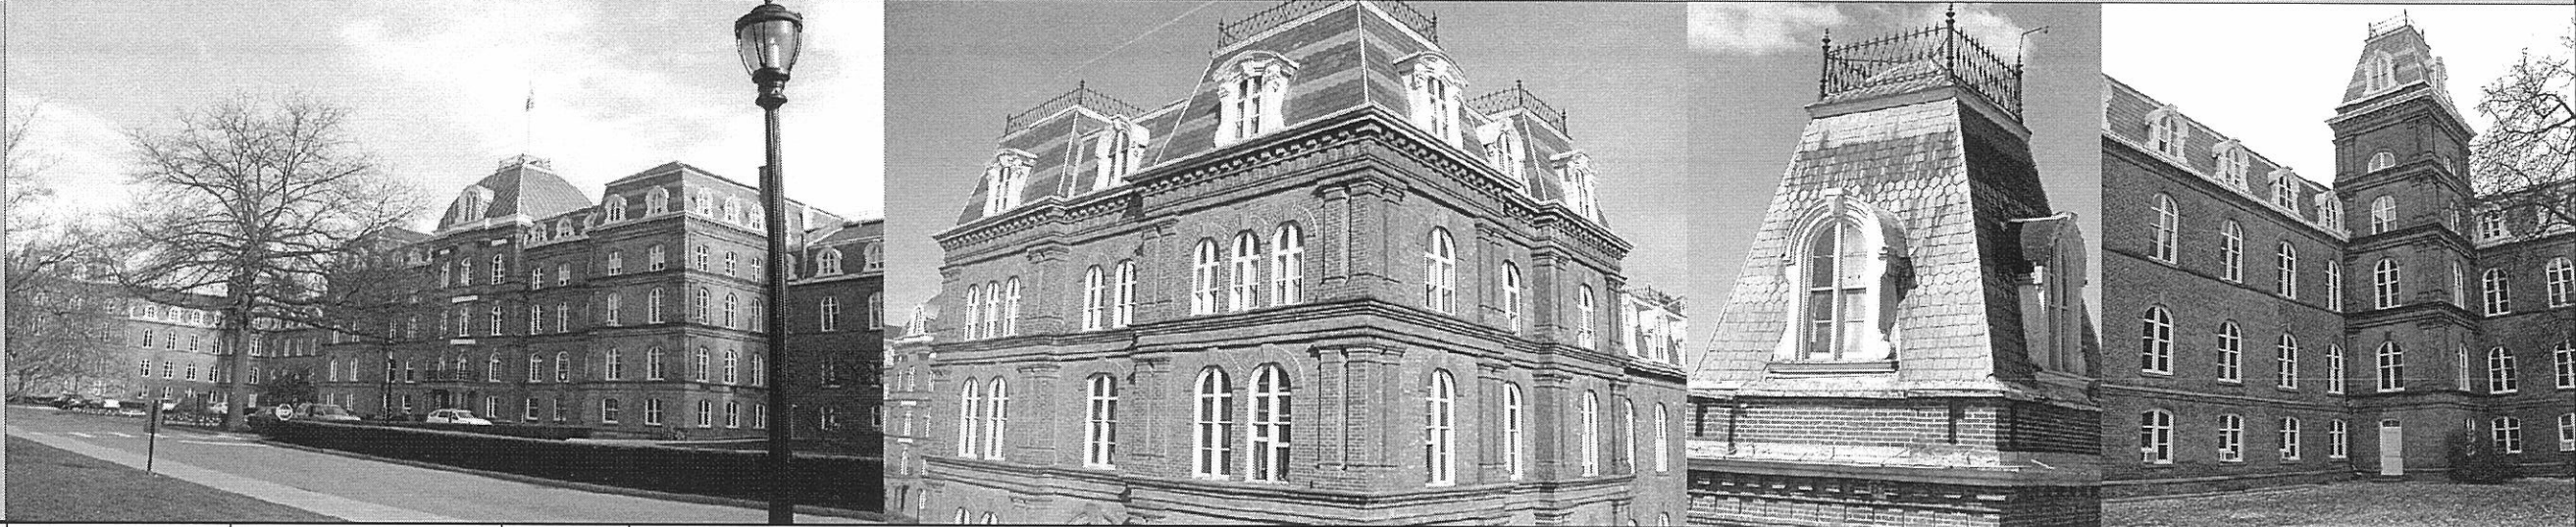
1	Main House

Item	Year of Installation	End of Service Life Year				2007	2008- 2010	2011- 2016	2017+		
1b	Low Slope	Built-up roof	Poor	Localized areas atop tower ends of north and south wings.	1980	2005	Weathertight	Limited review, 2004.	Replace with new built-up roof or other long-durability system.		X			30	
		Flat seam copper	Good	Dormer cap flashing in central section (either side of central dome), and perimeter of east elevation asphalt shingle gabled area.	2006	2066	Weathertight	Full replacement, 2006.	No recommended action.					60	Copper selected as replacement because of long-term durability and reduced maintenance relative to terne.
			Fair-Poor	Numerous gussets	1960	2010	Weathertight, draining.	Limited review, 2004.	Replace when roof replacement programs implemented.	X	X			50	
		Flat seam, painted tin/lead-coated steel (terne).	Fair-Poor	North and south tower window flashings, and all dormer flashings not replaced in 2006.	1865	Unlimited with maintenance.	Weathertight, draining.	Limited review, 2004.	Replace with flat-seam copper flashings to reduce maintenance.			X		60

Adhered EPDM	Good-Fair	Covering east wing, and surrounded by brick masonry parapet.	1990	2010	Weathertight, draining.	None	No recommended action.					30	Review and repair breaches as maintenance.
1c	Other, Skylights	Steel-framed wire-glass openings.	Fair-Poor	All skylights.	1865	2006	Clear, Weathertight, Structurally Sound	Limited review, 2004 & 2006.	Redesign and rebuild in accordance with anticipated future use.		X			100+	Unless leaking or deficient in some manner, address as part of roof restoration activities in local areas.
1d	Other, Chimneys	Brick masonry capped with bluestone.	Fair-Poor	North and south wing, western tower areas.	1865	Unlimited with maintenance.	Weathertight, structurally sound.	Limited review, 2004.	Repoint if functional, or dismantle and cap below roofline when roof coverings replaced.					Depends upon selected option.	Chimneys are not visible from ground sightlines and do not contribute to architectural identity.

1e	Other, Catwalks	Painted, galvanized steel pipe frame with pressure-treated lumber decking.	Poor	Central ridge of all wings.	1970	Unlimited with maintenance.	Structurally sound.	None	Replace wood decking and consider changing paint color to minimize aesthetic impact.	X	X			Depends upon deck material selected.	Code review required prior to implementing changes. Some catwalk rehabilitation is planned for 2007 with tower restoration projects.
1f	Other, Firewalls	Brick masonry through-wall flashed with lead-coated copper and capped in bluestone.	Good	East elevation firewalls closest to central dome.	1865	Unlimited with maintenance.	Weathertight, structurally sound.	Partially rebuilt, re-flashed and recapped in 2005.	No recommended action.					100+	
		Brick masonry through-wall flashed with lead-coated copper and capped in bluestone.	Fair	All other areas.	1865	Unlimited with maintenance.	Weathertight, structurally sound.	Limited review, 2004.	Review periodically, and rebuild as roof scope in area is undertaken.	X				100+	Two west elevation firewalls adjacent to north and south tower are planned for rehabilitation in 2007.

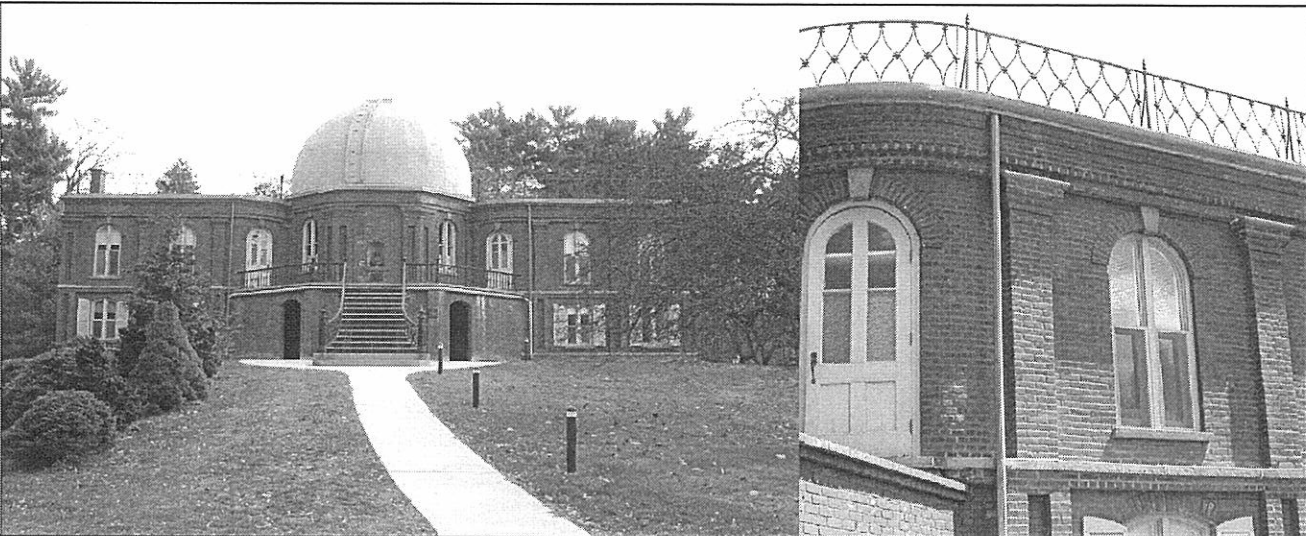
Item	Year of Installation	End of Service Life Year				2007	2008- 2010	2011- 2016	2017+		
1	Roof Construction														
1a	Pitched	Flat seam terne with elastomeric coating	Good	Dome at central plan	1865	Unlimited with maintenance.	Weathertight, aesthetically pleasing.	Limited review, 2004.	Maintain coating on terne.			X		Unlimited with maintenance.	
1b	Low Slope	Built-up roof	Fair	Localized areas atop tower ends of north and south wings.	1980	2005	Weathertight	Limited review, 2004.	Replace with new built-up roof or other long-durability system.			X		30-50 yrs	
		Bluestone pavers with underlying drainage and waterproof layer (bituthene)	Good	Main Porch at building entrance	2004	2039	Weathertight, draining.	Re-designed and reconstructed in 2004.	No recommended action.				X	35	
1c	Other,Chimneys	Brick masonry capped with bluestone.	Fair-Poor	At the end of each wing extending from dome	1865	Unlimited with maintenance.	Weathertight, Structurally Sound	Limited review, 2004.	Repoint & restore weathertightness to coping assembly.		X			Unlimited with maintenance.

1d	Other, Gutters	Closed terne-coated stainless steel gutter system	Good	Around main porch	2004	Unlimited with maintenance.	Weathertight, draining.	2004	No recommended action.					50+	
		Lead-coated copper running to on grade cast iron drains	Fair-Poor	From roof to grade throughout building	1970	2020	Weathertight, draining.	None	Replace at end of service life				X	50+	
2	Exterior Walls Construction														
2a	Mass Masonry, Composite	Typical walls: Brick masonry with decorative brick pilasters, arches, and dentil courses.	Fair	All elevations.	1865	Unlimited with maintenance.	Weathertight, structurally sound, Aesthetically pleasing.	Limited review and repair, 2004	Repoint to renew weathertightness matching existing.		X			Unlimited with maintenance.	
		Typical window sills: Bluestone	Fair	All elevations.	1865	Unlimited with maintenance.	Weathertight.	Limited review, 2004.	Seal cracks or replace unit to restore weathertightness.		X			Unlimited with maintenance.

Decorative bluestone elements: pilaster caps, band courses, keystones	Fair-Poor	All elevations, localized units: poor drainage and erosion.	1865	Unlimited with maintenance.	Weathertight, draining.	Limited review, 2004.	Replace irretrievably damaged units with matching materials.		X			Unlimited with maintenance.	Coordinate with masonry restoration programs in local areas.

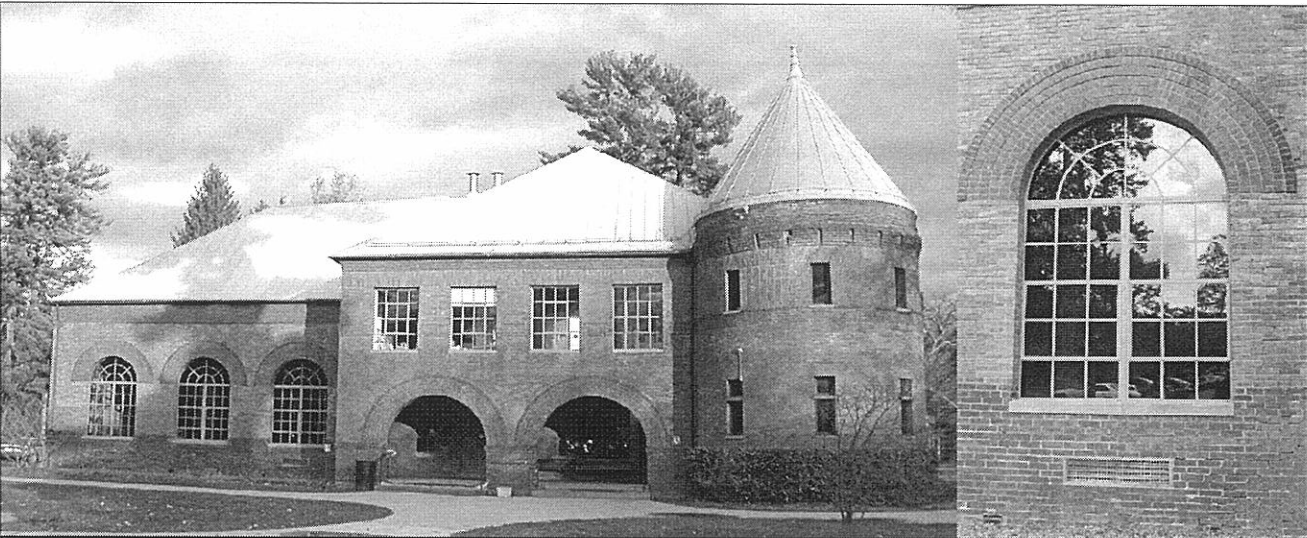
Item	Year of Installation	End of Service Life Year				2007	2008- 2010	2011- 2016	2017+		
1	Roof Construction														
1a	Pitched	Standing seam terne roof, coated with an acrylic system.	Fair	All slopes.	1906	2056	Weathertight	Limited review, 2004.	Review condition in detail and make localized repairs. Install new gutter system.	X	X			n/a	Terne roof system can last indefinitely if proper coating maintained. Present roof is old, and possibly original, but is too deteriorated under coating and must be replaced. Original gutter system abandoned and largely removed, but absence is impacting brick masonry.
		Galvanized gutter, south-west turret.	Poor	Localized area.	1980	2010	Weathertight, Structurally Sound	Limited review, 2004.	Replace with new system, presumably copper or aluminum.	X				40	New gutter selection dependent on complete roof assessment.
1b	Low Slope	0.060 mil thick, fully adhered EPDM Carlisle systems.	Fair	Localized area.	1990	2010	Weathertight	Limited review 2004; Localized repairs, 2006.	Repair seams and strip in at gravel stop to extend remaining service life.		X

1c	Other, Skylights	Steel-framed glass openings.	Poor	All skylights.	1906	2006	Clear, Weathertight, Structurally Sound	Coated in 2005, and non-functional.	Redesign and rebuild in accordance with anticipated future use.		X			100+	Address in advance of roof rehabilitation program to minimize damage of new roof systems.
2	Exterior Walls Construction														
2a	Mass Masonry, Composite	Typical walls: Brick masonry.	Fair	At ground level and on turret, outer wythe of masonry displaced and damaged from excessive, on-going water exposure.	1895	Unlimited with maintenance.	Weathertight, Structurally Sound	Limited review, and localized stabilization of turret, 2004.	Address roofing, then reset brick and repoint in affected areas.		X			50+	Poor roof drainage control is unraveling masonry in splash areas.
		Typical window sills: Bluestone	Fair	Cracked at centerpoint, random units.	1895	Unlimited with maintenance.	Weathertight	Limited review, 2004.	Seal cracks or replace unit to restore weathertightness.		X			50+

3	Windows														
3a	Fixed	Steel frame with divided lights.	Fair	Corrosion of steel frames and mullions undermining weathertightness.	1944	2009	Weathertight	none	Review window systems and replace with long service life option.		X	X		80	Windows have been replaced and changed since 1944. Examine options and replace with aesthetically similar units.
3b	Operable	Wood frame with divided lights (wooden sills).	Poor	Wood rotten, and not weathertight.	1944	2009	Weathertight	none	Review window systems and replace with long service life option.		X	X		80

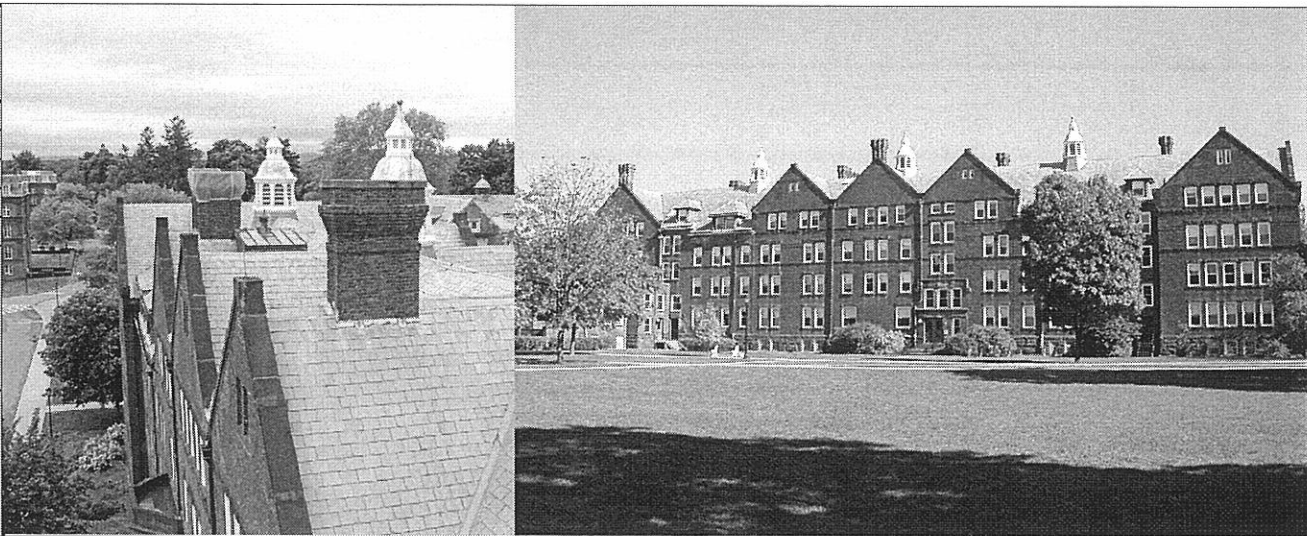
Item	Year of Installation	End of Service Life Year				2007	2008- 2010	2011- 2016	2017+		
1	Roof Construction														
1a	Pitched	Vermont fading green slates, numerous replacements.	Good	All slopes.	1980	2080	Weathertight	Limited review and repairs, 2005.	Replace missing or cracked slates as needed.			X		100+	Replace deteriorated slates during flashing rehabilitation project.
		Copper flashings and built-in gutter system.	Poor	All areas	1980	2010	Weathertight, Structurally Sound	Limited review and repairs, 2005.	Replace all flashings, and install through-wall flashing under coping stones.			X		60	
1b	Low Slope	Low-rise portion of building, presumably with coal tar system.	Fair	Localized area.	Unknown, presumed 1980	2010	Weathertight	None	Replace as part of a full roof rehabilitation.			X		Depends upon selected system.	
1c	Other, Chimneys	Six chimneys originally constructed with two wythes of masonry with bluestone caps.	Excellent-Good	Five chimneys partially rebuilt in 2005, and the sixth was repaired.	2005	2080	Weathertight, Structurally Sound	Limited review in 2004, and stabilized with netting. Rebuilt in 2005.	No recommended action.					75

1d	Other, Dormers	Similar to main roof.	Good	All slopes.	1980	2080	Weathertight	Limited review, 2005.	Replace missing or cracked slates as needed.			X			Replace deteriorated slates during flashing rehabilitation project.
1e	Other, Cupolas	Timber framed, louvered painted walls with painted terne cap.	Fair	Louvers leak, and finials have been falling off.	1902	Unlimited with maintenance.	Weathertight, Aesthetically pleasing.	Limited review, 2004.	Review conditions, and restore paint system. Secure or replace loose finials.			X			Unlikely all present components are original, and further investigation required.
2	Exterior Walls Construction														
2a	Mass Masonry, Composite	Typical walls: Brick masonry.	Fair	Areas under gutters and coping stone mortar joints are open.	1893	Unlimited with maintenance.	Weathertight, structurally sound.	Limited review in 2004, and stabilization in 2005.	Address roofing, then repoint affected areas. Remove coping stones and reset atop through-wall flashing.			X		50+	Improving the roof drainage system will decrease rate of deterioration.

Brownstone trim elements: typical window lintels, coping stones, beltcourse.	Fair	Open mortar joints undermine weathertightness.	1893	Unlimited with maintenance.	Weathertight.	Limited review, 2004.	Seal cracks or replace unit to restore weathertightness.			X		50+

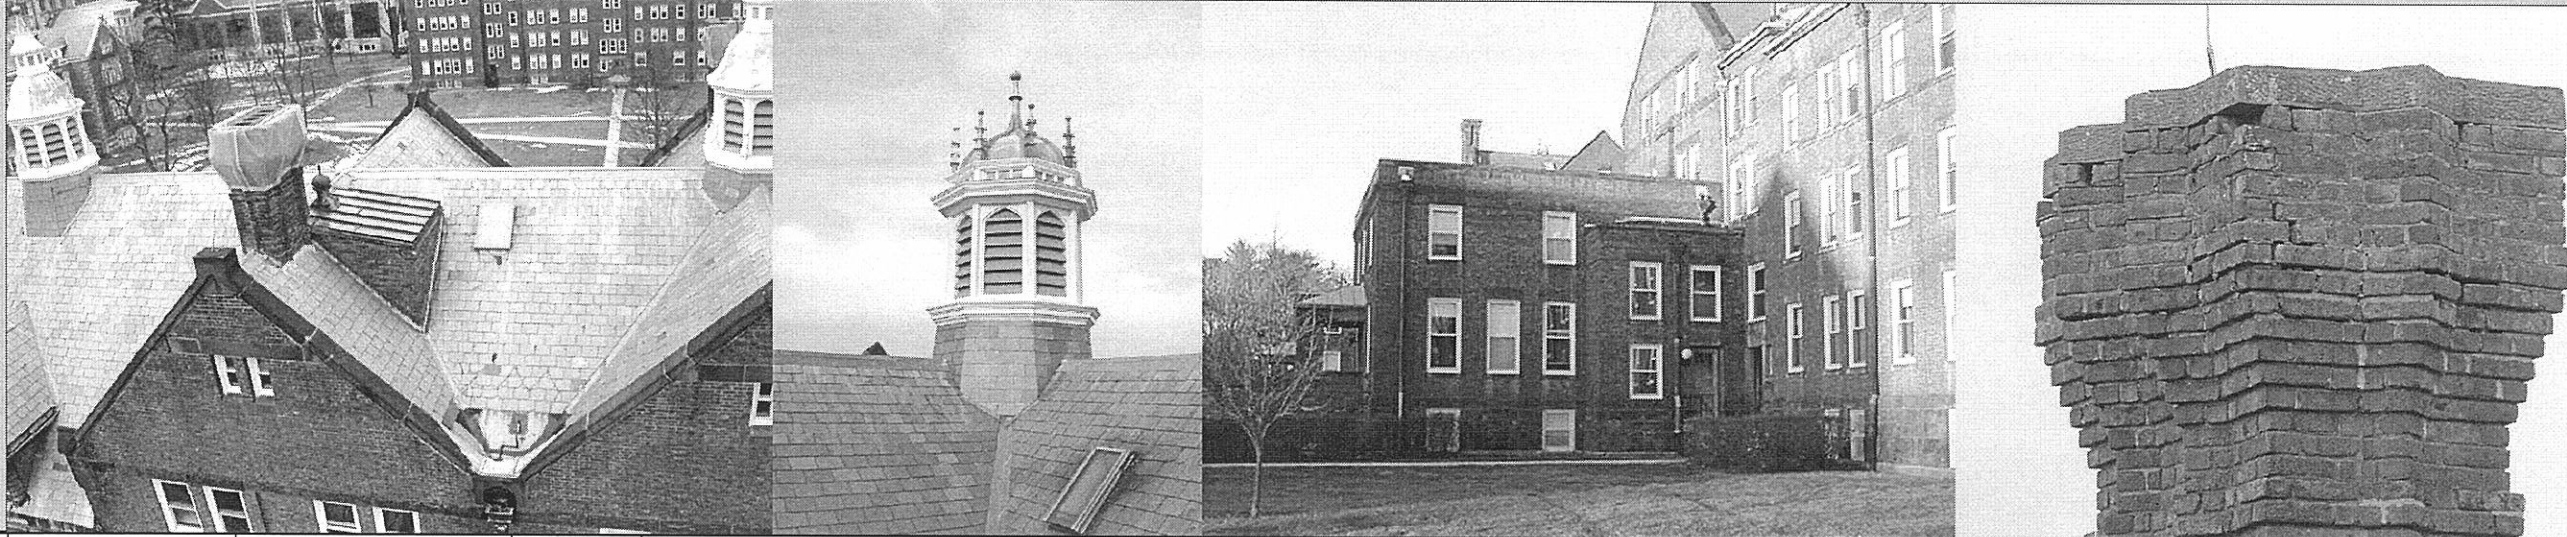
6	Strong House

Item	Year of Installation	End of Service Life Year				2007	2008- 2010	2011- 2016	2017+		
3	Windows														
3a	Operable, single-hung.	Wood frame and sashes.	Fair	Window frames not sealed at perimeter, aesthetic concerns.	1980	3	Weathertight, aesthetically pleasing.	none	Review window systems and replace with long service life option.			X		30	Windows appear to remain functional but are nearing end of service life.
4	(Other Building Components- as required)														
4a	Mass Masonry, Composite	Main Quadrangle entrance: original brownstone elements, proesumed to be framed by brick piers.	Fair	Weathered appearance is aesthetically displeasing.	1893	2006	Structurally stable, aesthetically pleasing.	Limited review, 2004 and 2006.	Rebuild 100%.		X			100+	To be coordinated with plans for interior renovation of residence hall.
4b	Mass Masonry, Composite	Main Road entrance: original brownstone elements, new brick.	Excellent	Entire staircase rebuilt, 2005.	2005	2105	Structurally stable, aesthetically pleasing.	Rebuilt in 2005.	No recommended action.					100+

4c	Mass Masonry, Composite	Low-rise staircase: steel framed with concrete, brick, bluestone, and brownstone composite masonry.	Fair	Staircase partially rebuilt, but on-going deterioration and corrosion of steel.	1985	2015	Structurally stable, aesthetically pleasing.	Limited review, 2006.	Selective rebuild, replacement of staircase treads, localized masonry repairs.			X		40	Condition of staircase does not mandate immediate intervention, but may consider coordination of this rehabilitation within larger masonry program planned for 2009.

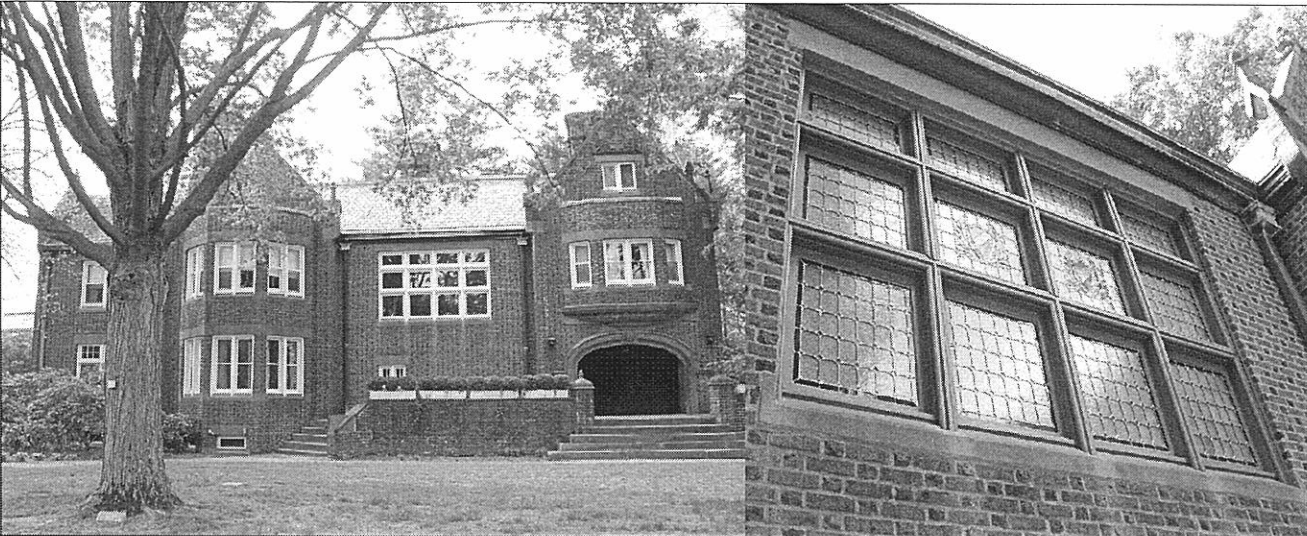
Item	Year of Installation	End of Service Life Year				2007	2008- 2010	2011- 2016	2017+		
1	Roof Construction														
1a	Pitched Mansard	Black slate, potentially from Monson, Maine. Some replacement slate is PA black.	Good	All slopes.	1930	2046	Weathertight	Limited review 2004; Localized repairs, 2006.	On-going review and localized slate replacement.		X			2046	Although not essential, consider replacing slate at same time as flashings to extend time until next replacement from 40 to 60 years. Coordinate all replacement with other roof systems.
		Copper flashings, gutters.	Poor		1990	2010			Replace all flashings, add through-wall flashings under coping stones, and replace gutters.		X			60	
1b	Low Slope, EPDM	0.060 mil thick, fully adhered EPDM Firestone systems. Original systems likely flat-seamed copper.	Fair	Above east entrance.	1990	2010	Weathertight	Limited review 2004; Localized repairs, 2006.	Replace EPDM with flat-seam copper system.		X			60	Lower cost, shorter service life systems are available (EPDM, etc.).

Fair	Central top roof.	1990	2010			Replace EPDM with flat-seam copper system.		X			60	
1c	Other, Brick Chimneys	Single-wythe brick construction, with multiple unlined openings.	Fair	All chimneys, deteriorated masonry construction.	1895	2010	Weathertight, Structurally Sound	Localized repairs, 2006.	Redesign and rebuild in accordance with anticipated future use.		X			100+	Address in advance of roof rehabilitation program to minimize damage of new roof systems.
1d	Other, BUR	Coated system.	Good	Area above southern alcove.	Unknown, presumed to be 1980.	2020	Weathertight, Draining	Limited review, 2004.	Repair or replace to retain weathertightness as part of roof replacement program.		X			Depends upon selected system.	
2	Exterior Walls Construction														
2a	Mass Masonry, Composite	Typical walls: Two wythes of brick tied to wood frame.	Fair	Weathered mortar joints, and damaged masonry from excessive exposure to water.	1895	Unlimited with maintenance.	Weathertight, structurally sound.	Localized repointing, 2006.	Repoint to address water infiltration in critical areas.	X	X			50+
